# Serviceordre – Materieell

## SERVICEORDRE – 2015-01

## PRODUCT SERVICE BULLETIN 2015-01

**SUBJECT:** EXCESSIVE URETHANE COATING ON SPECTRA RESERVE RIPCORD

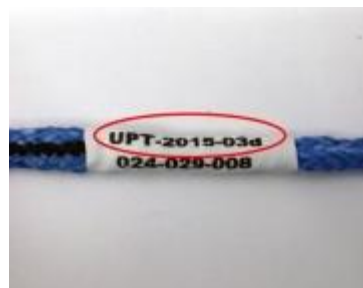
<b>HENVISNING:</b>	UPT Product Service Bulletin 2015-01
<b>FORMÅL:</b>	Utskiftning av spectraline på reservehåndtak
<b>STATUS:</b>	<b>Obligatorisk – før neste hopp!</b>
<b>IDENTIFIKASJON:</b>	Alle UPT reservehåndtak er merket med et LOT# angitt på en merkelapp på selve spectralina. Følgende LOT# er berørt:

UPT-2014-01  
UPT-2014-08  
UPT-2014-10  
UPT-2014-11  
UPT-2015-02  
UPT-2015-03  
UPT-2015-03a  
UPT-2015-03b  
UPT-2015-03c  
UPT-2015-03d

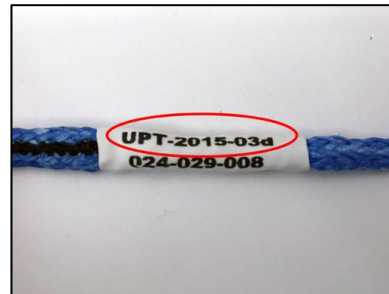
*Locate the white sleeve on the Spectra reserve ripcord.  
The top line will read the lot # as "UPT-201X-XXX"*

LOT # UPT- 2015-04 AND LATER ARE NOT SUBJECT TO THIS PSB.

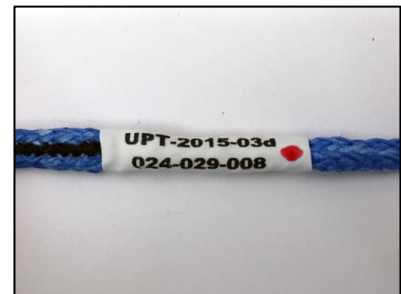
As a reminder use a Sharpie or similar permanent marker, and put a visible dot on the ripcord data sleeve. This will represent the initial treatment performed in June.

When you re-lubricate in July, put a second dot on the backside of the data sleeve, a third in August, and so on, until the replacement can be installed. This will allow any jumper to keep track of the monthly lubrication while the interim solution is in effect.
